San Ignacio Heights is located in Green Valley AZ, an unincorporated community in Pima County. Each of the 80 subdivisions in Green Valley has an HOA. Many of these are responsible for street maintenance. Each HOA is represented by the Green Valley Council. It incorporated as an Arizona 501(c)(4) Corporation in 1973. The Council is an all-volunteer organization that serves as the community's "Civic Voice." It acts as Green Valley's liaison for governmental relations with local municipalities, the City of Tucson, Pima County, the State of Arizona, as well as Federal and Tribal governments.

San Ignacio Heights (SIH) was developed by Fairfield Homes beginning in 1990. The Community was constructed in four phases, with portions of the Community being built in 1990, 1991, 1992, and 1997. This makes the infrastructure, streets, sidewalks, sewer and water lines approximately 25 to 32 years old.

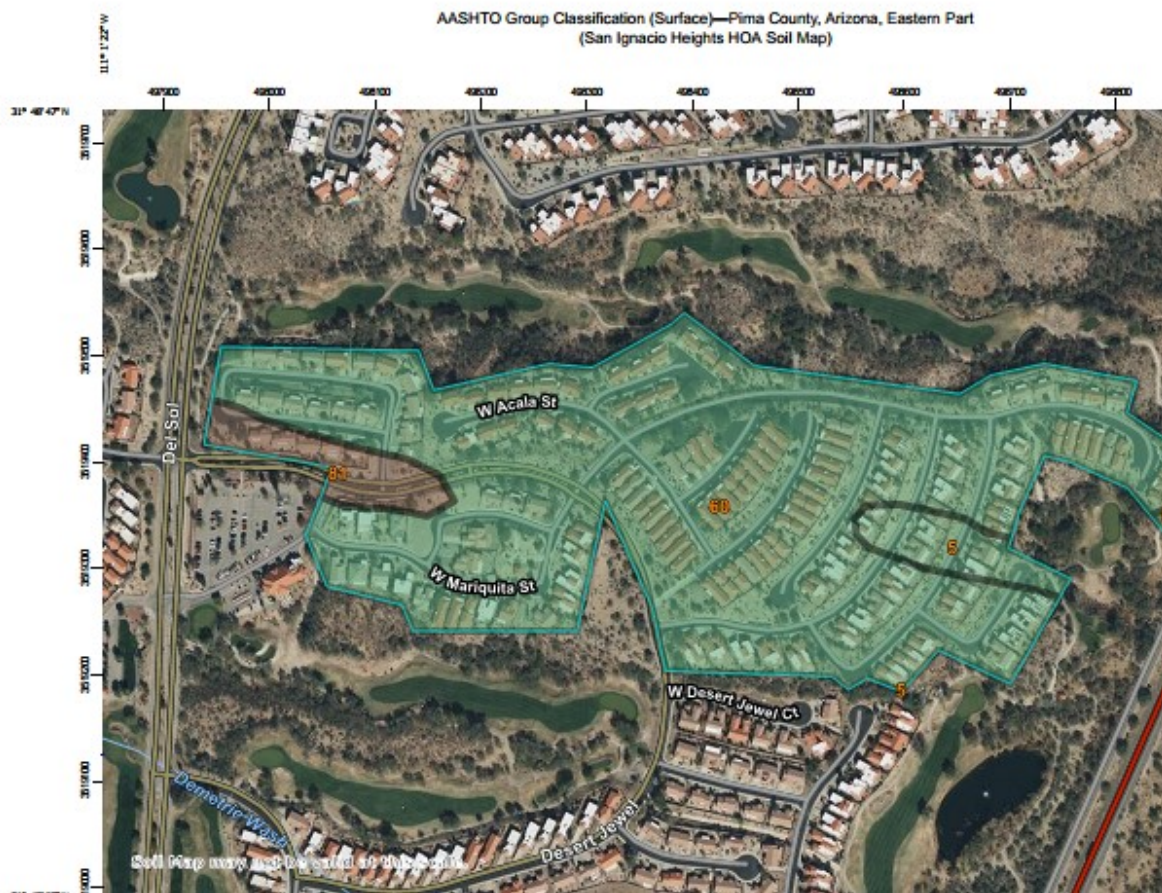
The soils in the SIH HOA are an excellent road base. This is a main reason why our streets held up so well. They are a great mix of cobble, gravel, sand, silt and clay that is further cemented in areas with CaCO3 (lime) the same stuff used in concrete. The ratings on the USDA Soil Survey 5/ show that you can drive heavy military vehicles on them with little effect. The majority (47 acres) of the soils in the approximately 50 acre area delineated in the map below have an American Association of State Highway and Transportation Officials (AASHTO) rating of A-1 (excellent) for subgrade.

AASHTO Group Classification (Surface)—Pima County, Arizona, Eastern Part San Ignacio Heights HOA Soil Map
